## UK Case Study – Birkenhead Commercial Development

This site was planned for development as a commercial warehouse and associated hard-standing areas (Loading bays and Lorry Park).

Landpac was requested to perform HEIC treatment of “External Areas” of  $\pm 4$  Ha to address concerns relating to future settlement and differential settlement under service loading of the hardstand areas surrounding the warehouse.

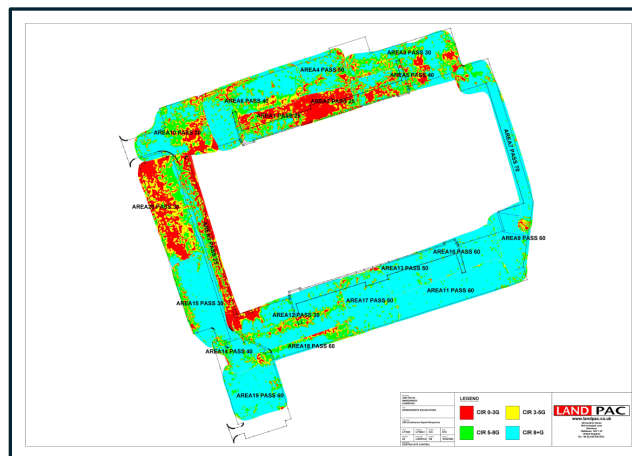
### Ground Improvement by Landpac HEIC treatment

Landpac HEIC treatment led to a **Homogenization and Improvement of the Ground Bearing Capacities** of the external areas and highlighted the remaining **“Soft/Weak”** areas.
