UK Case Study – Castlegate, Caerphilly Residential Development

The proposed development occupied an area of approximately 6 Ha and included a residential development of short terraces and semi-detached houses.

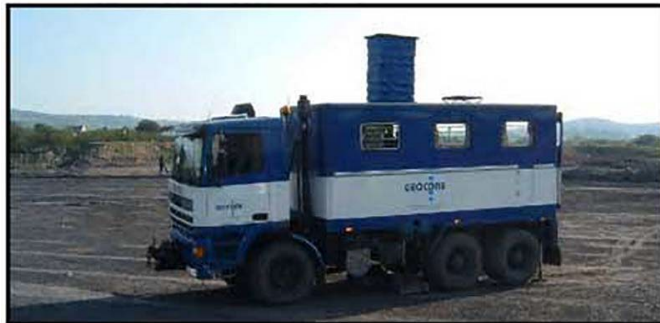
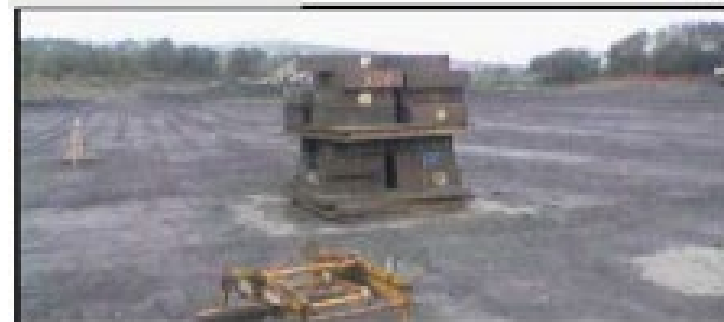
127 SCPT tests were performed on site which confirmed uniformity of the treated PFA at the site. The testing also confirmed an Increase in Cone Resistance to **around 4m bgl**.

The verification testing for this site included a suite of SCPT testing and Zone Load testing.

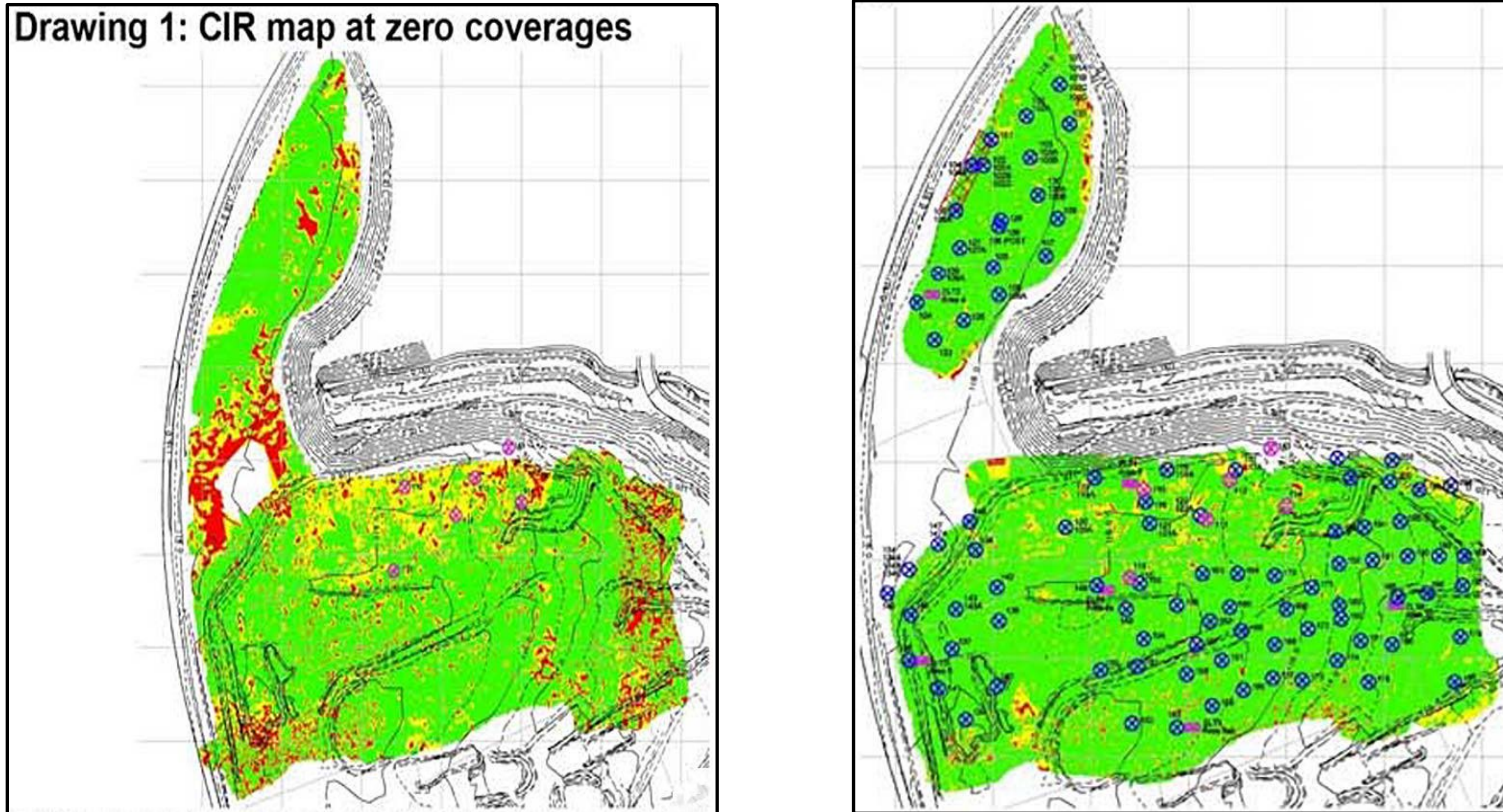
Drawing 1: CIR map at zero coverages

Landpac CIR measurement highlighted the area of the site that could not be treated with HEIC.

Further treatment with HEIC of the other areas led to improved bearing capacities and homogenization of the in-situ materials
